State Historic Sites Inventory Form

and/or common Windolph/Williams Farm

street & number 16420 Darnestown Road not for publicationcity, town Dawsonville X vicinity of congressional district

Survey No. M: 18-23-2

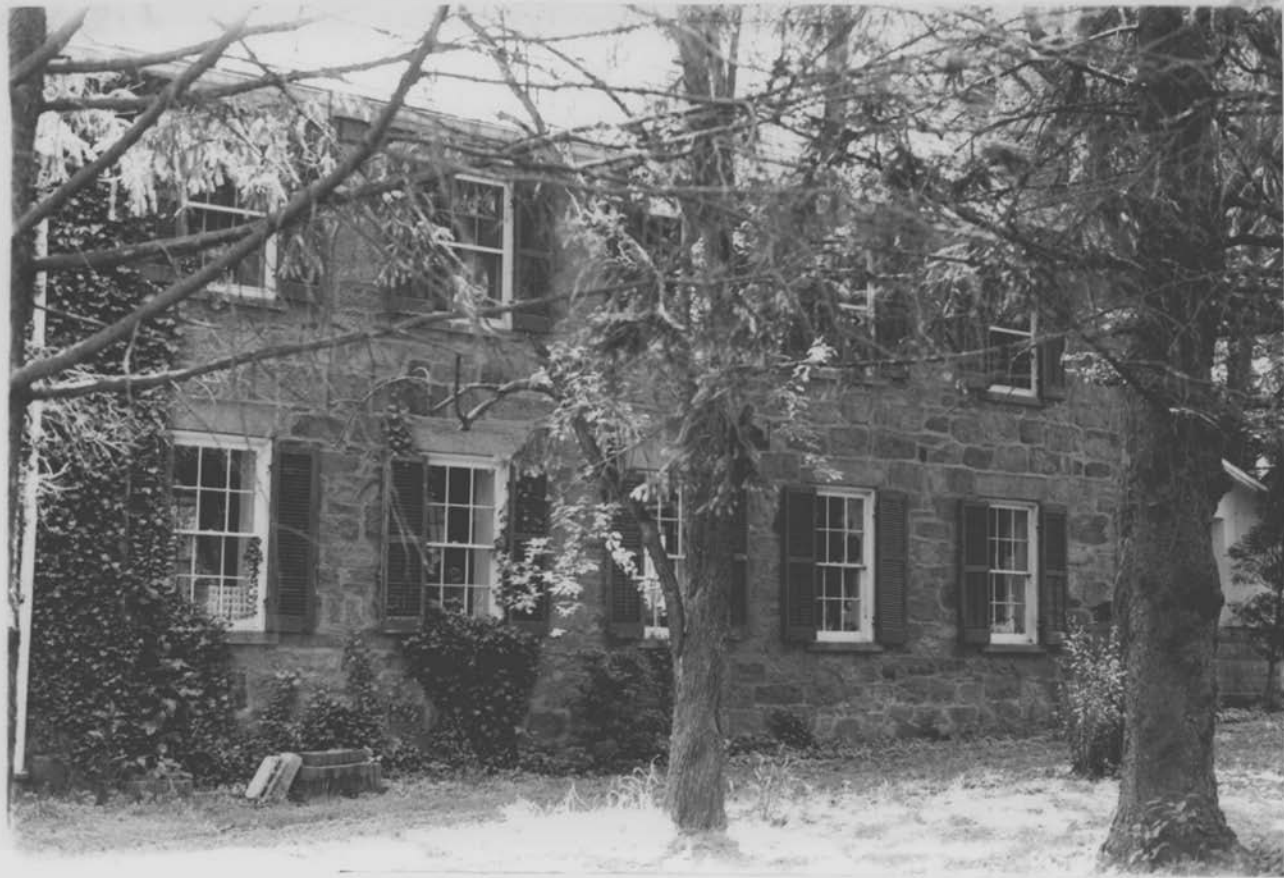
NAME ALLNUIT / WINDOLPH HOUSE
16470 Darnestown Rd (MD 28)
LOCATION Rt 28 + 107 DAWSONVILLE Md
FACADE W
PHOTO TAKEN 5/17/74 MOWVER

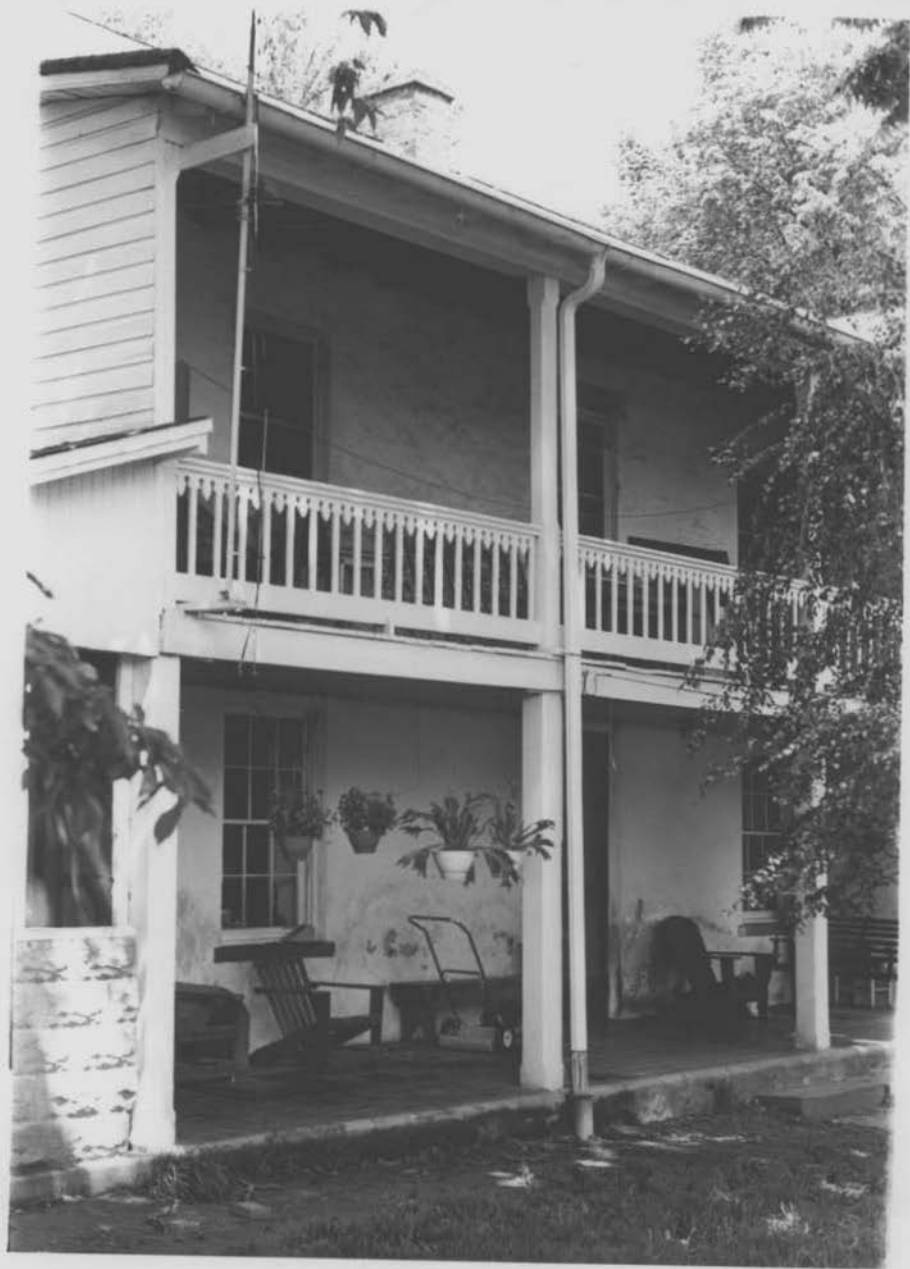
NAME NATH. ALLNUTT HOUSE #18-23-2
LOCATION 16420 Darnestown Rd (MD 28)
Rt 107 + Rt 28 DAWSONVILLE, MD
FACADE S WING - SE FACADE
PHOTO TAKEN 5/17/74 MONYER

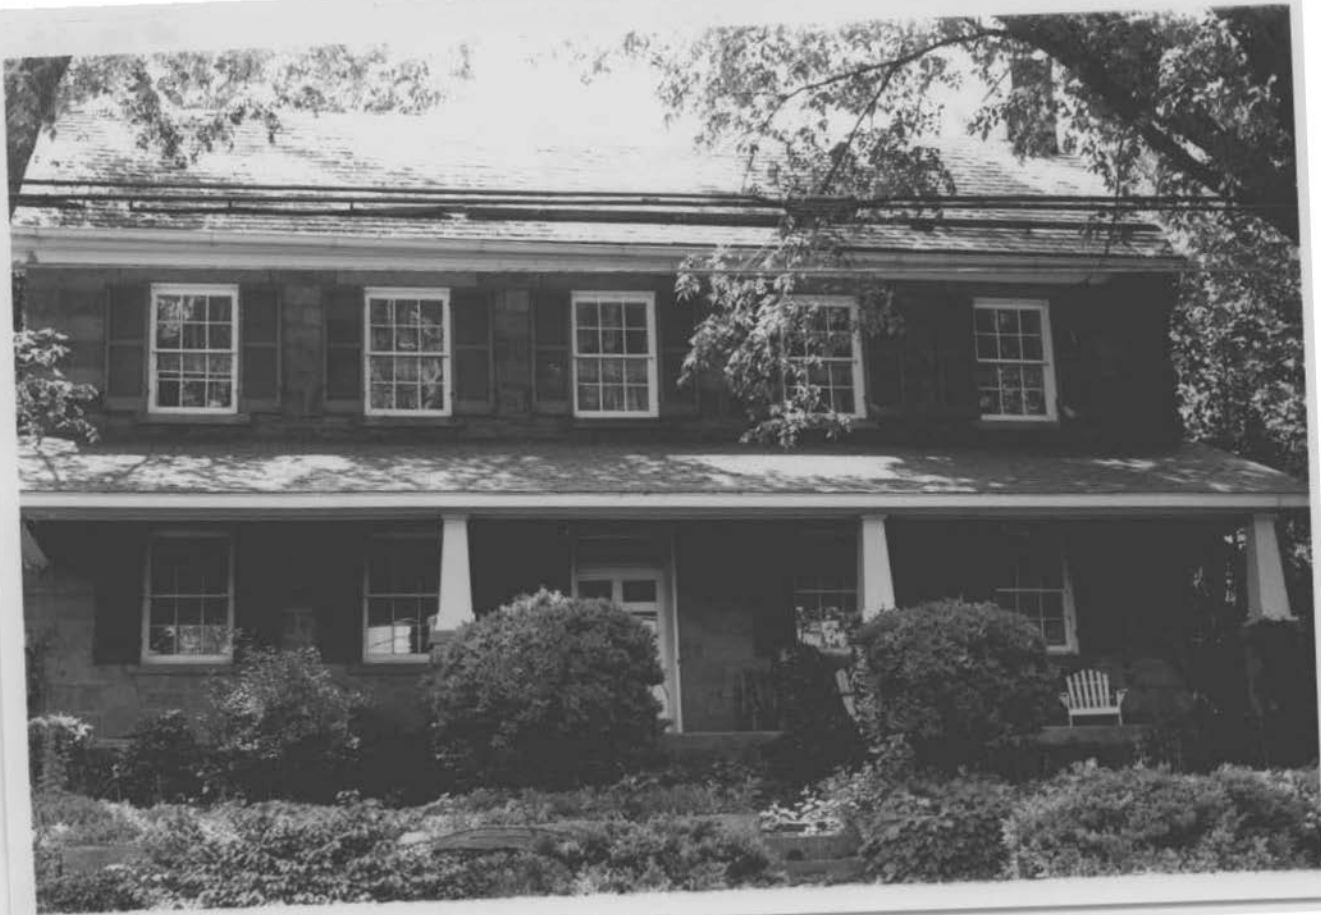
#18-23-2

NAME ALLNUTT / WINDOLPH HOUSE
LOCATION 16420 Darnestown Rd (MD 28)
RA 284107 DAWSONVILLE, Md
FACADE N
PHOTO TAKEN 5/17/74 MDWVER

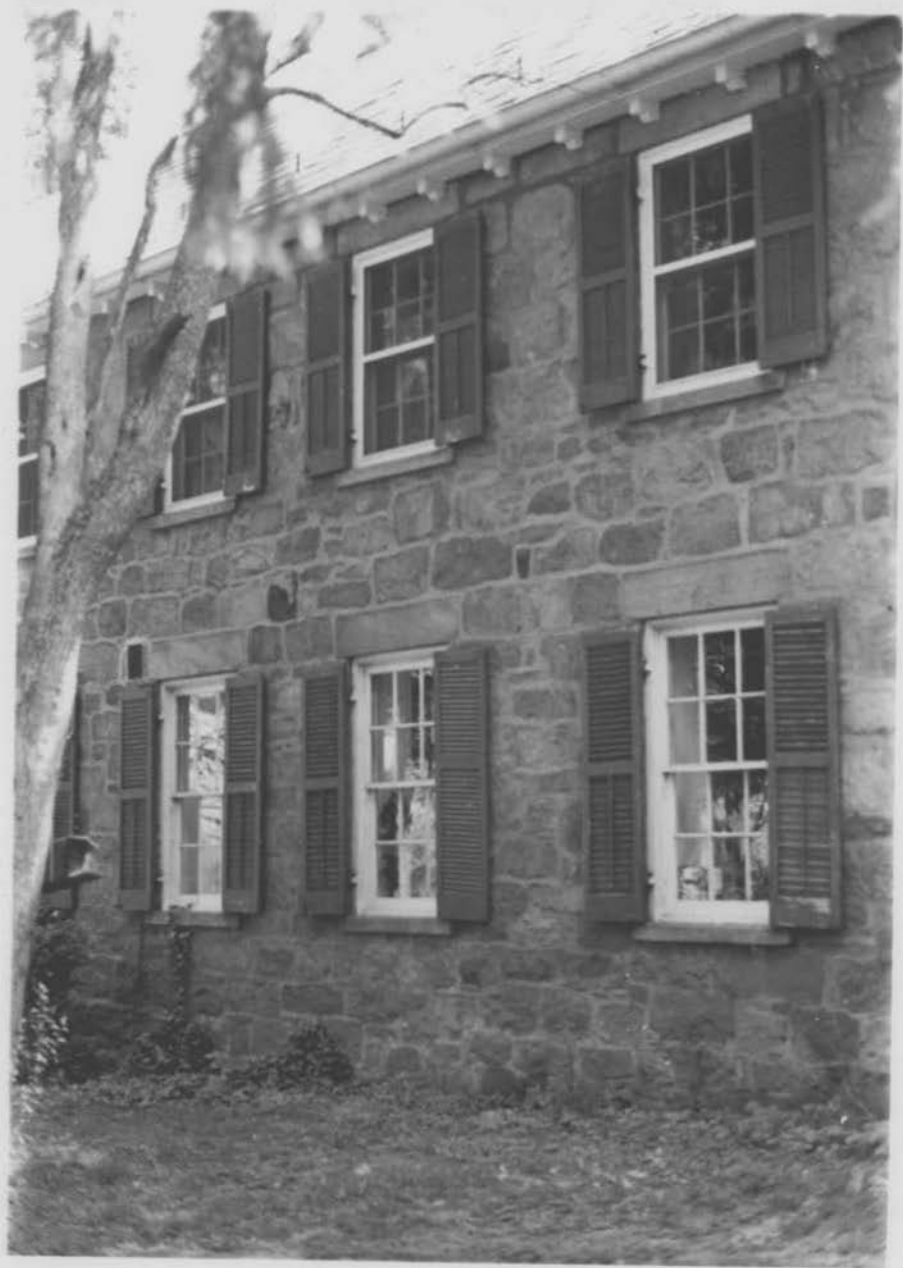
NAME NATH. ALLNUFF HOUSE #18-23²
LOCATION 16420 Darnestown Rd (MD 28)
Rt 107 + Rt 28 DAWSONVILLE, Md
FACADE S WING - W FACADE
PHOTO TAKEN 5/17/74 MDWYER

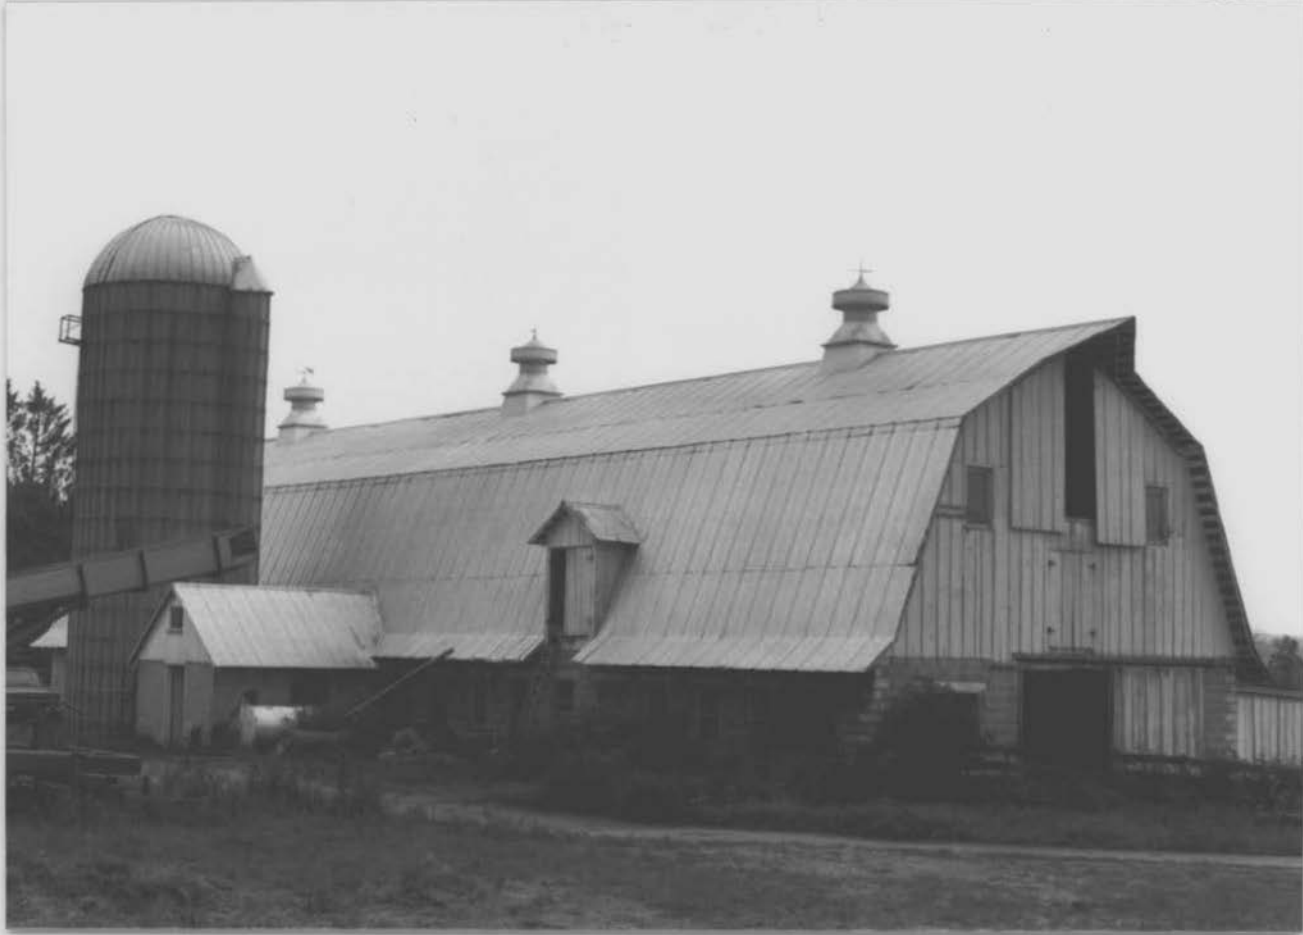
M: 18-23-2

c. 1930 cow barn

Looking northeast

The largest of these is the huge concrete block dairy barn. Twenty-one bays long, this barn is constructed of rock-faced concrete block, with smooth-faced white blocks used as quoins at the corners. The windows have white painted wood lintels. A small, gable roof, smooth-faced concrete block wing projects from the center of the west elevation. Two gabled dormers sheathed with vertical board-and-batten siding project from the roof. A Concrete stave silo with domed sheet metal roof stands just north of the wing. A small gable roof, smooth concrete block dairy stands at the north end of the east elevation. German siding covers the gable ends which contain a small, rectangular, louvered opening. A concrete block flue rises along the east wall of the dairy. A lean-to addition containing box stalls has been added to the east elevation. The north and south elevations are identical, each having at ground level a wide center doorway covered by a vertical board-and-batten rolling door. To each side of the doorway are pairs of windows containing 12-light wood sash. Above this, the gambrel ends are sheathed with vertical board-and-batten siding. Board-and-batten shutters cover a smaller opening beneath the large central opening into the hayloft. The doors for this opening, also vertical board-and-batten, roll diagonally up to close. On either side of these doors is a single window with 12-light sash. The gambrel roof is covered with sheet metal and has three large metal ventilators which sport weathervanes.

The concrete block dairy barn is significant for its size. It is one of the largest dairy barns to be built at this time in Montgomery County. Many barns grew to be this size with later additions, but from the start the Windolph barn was 21 bays long (or 22, depending on how one counts the bays). This must have been an enormous investment at that time.

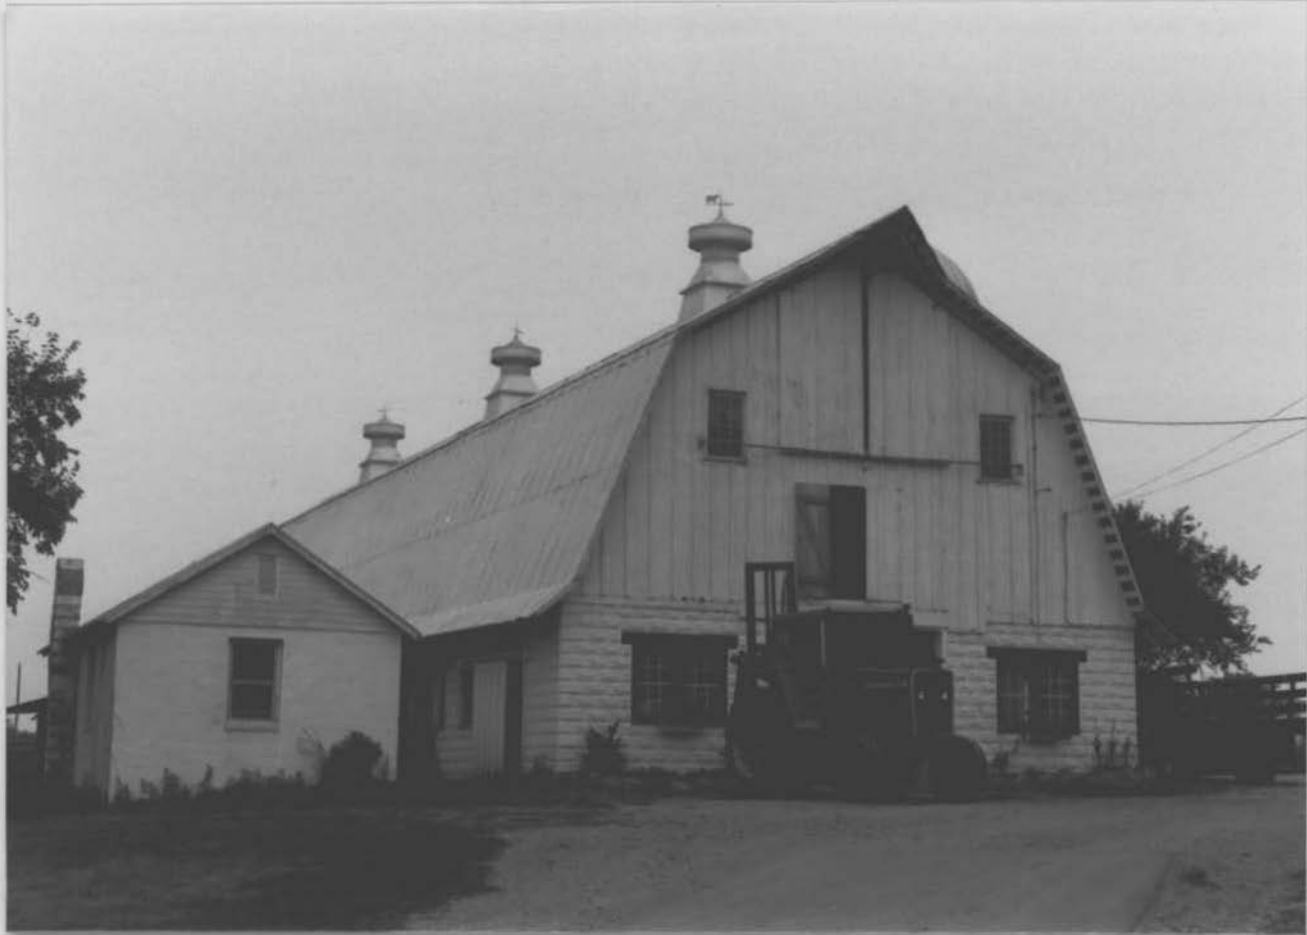
M: 18-23-2

c. 1930 cow barn

North elevation

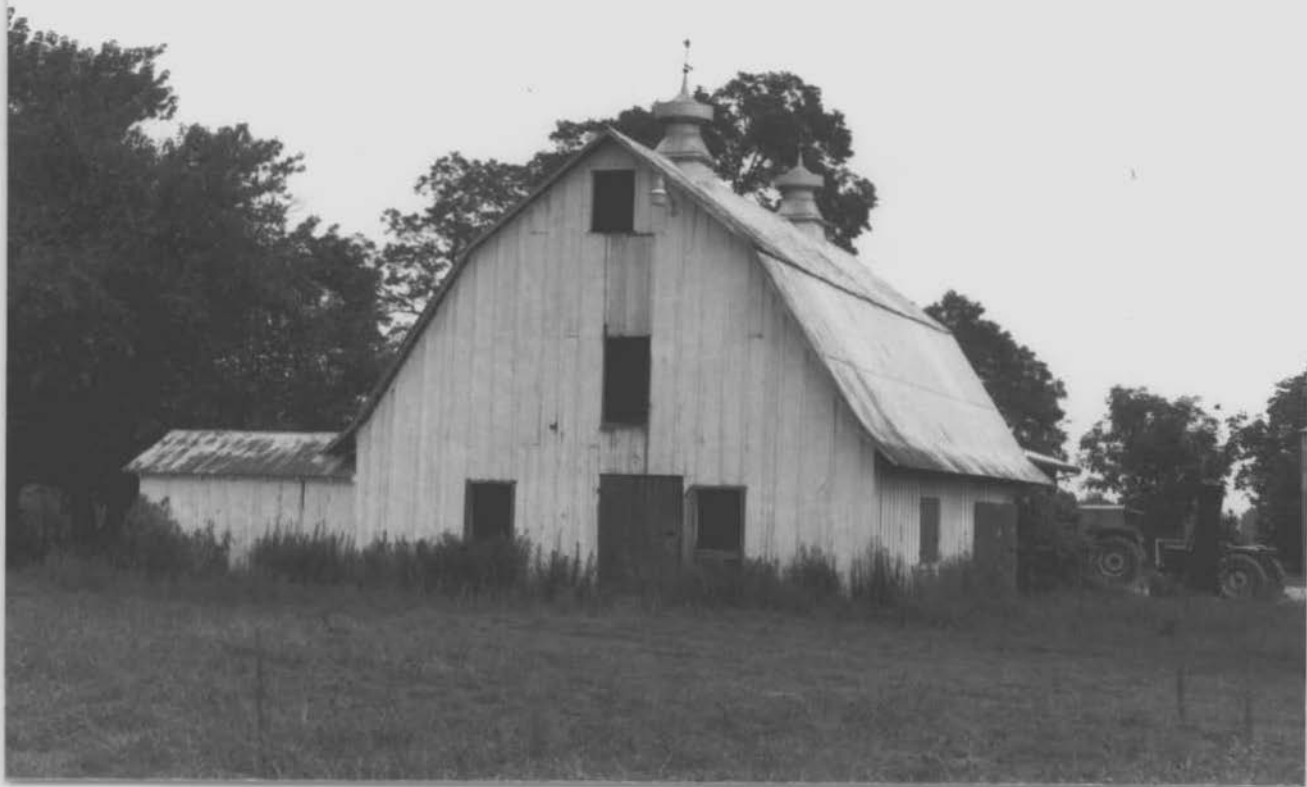
M: 18-23-2

c. 1930 horse barn

South elevation

The horse barn, built just after the dairy barn, is a wood frame, gambrel roof structure with vertical board-and-batten siding, resting on a foundation of rock-faced concrete blocks. The metal covered roof has two large sheet-metal ventilators topped with a spire and ball, and a weathervane with a five-pointed star at the tip. The north elevation has a small, central, board-and-batten door with a single window on either side. Halfway up the elevation is a small hinged wood door, and directly above that is a large opening with inward swinging double doors giving access to the hayloft. The east elevation contains three more board-and-batten doors, the north one being a dutch door. The south elevation contains a central door with a window on each side, a window opening halfway up the elevation, and a smaller opening at the peak of the gambrel. A one-story, gable roof wing projects from the southern end of the west elevation. Inside the barn has been altered by the removal of most of the box stalls. It is currently being used as a hog confinement barn.

The horse barn and the grainery, built shortly after the dairy barn, are significant because they follow older trends in barn design and construction. Sheathed mostly in vertical board-and-batten siding, they are heavy sawn timber structures. One reason for the discrepancy in construction types may be their intended use. By the early 1930's dairy barns were required to be sanitary structures, i.e., sealed against dirt and dust, and easily kept clean. Concrete was the material of choice for such a building. Concrete floors replaced dirt floors, concrete block walls plastered on the inside replaced wood studs and sheathing, and ceilings finished in matched (tongue-and-groove) boards replaced open joists through which dust could sift down between the cracks in the hayloft floor. Concrete was more expensive than wood, however; most farmers could cut the lumber needed for a barn from their own woods, whereas concrete had to be purchased. This probably explains why the dairy barn was built of concrete block, and the other two farm buildings of wood. The tavern, being a commercial structure, warranted the more attractive, rusticated concrete block.

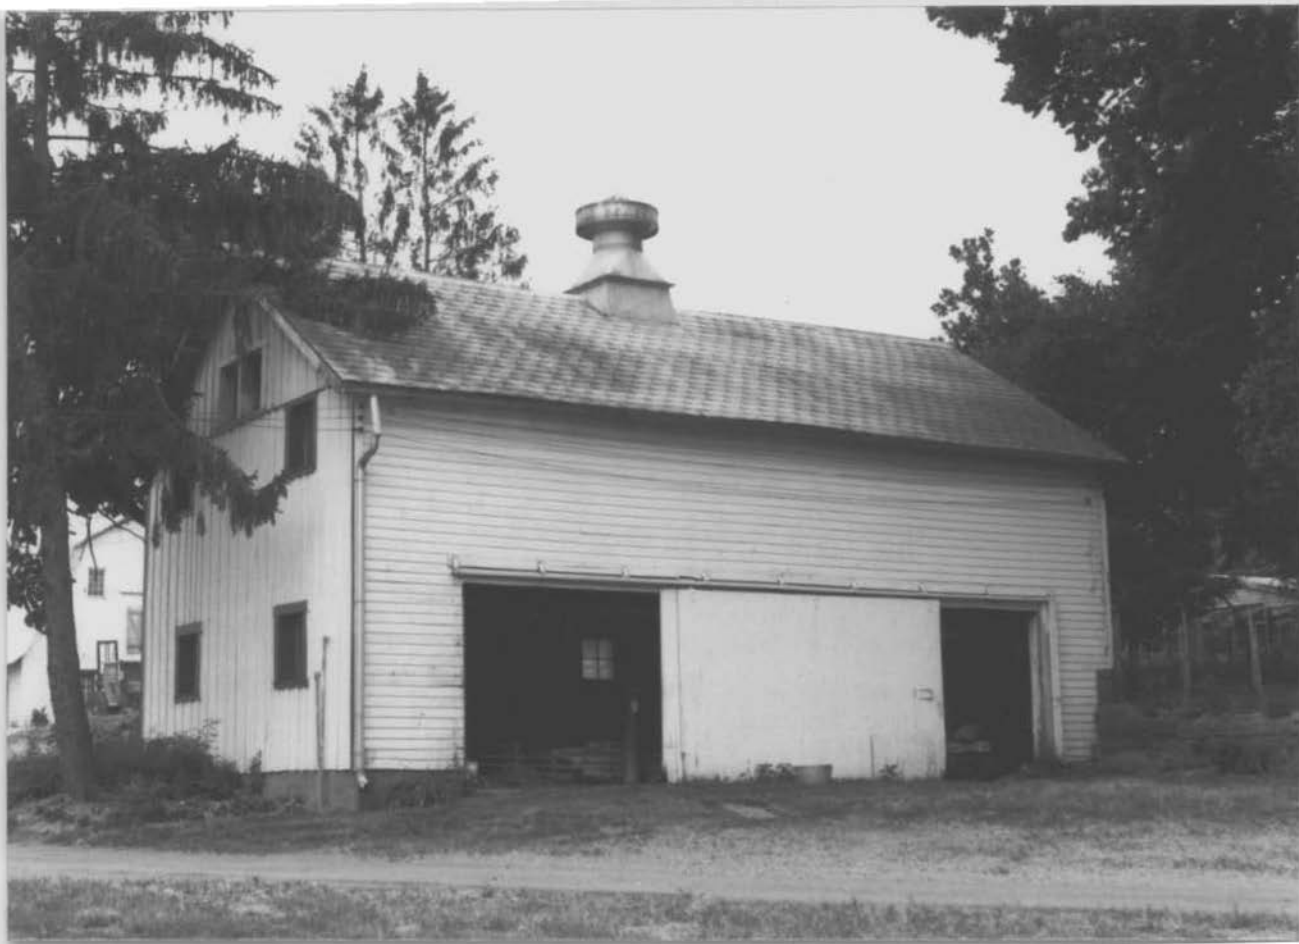
M: 18-23-2

Grainery

Looking southwest

The grainery, c. 1930, is a gable roof, heavy wood frame structure on a poured concrete foundation. The north elevation is sheathed in German siding and has wide, horizontally rolling wood doors covering the large opening spanning most of its length. The other three elevations are sheathed in vertical board-and-batten siding and have wood framed windows with trim painted green. The roof is covered with composition shingles and has a single, large, sheet metal ventilator in the center.

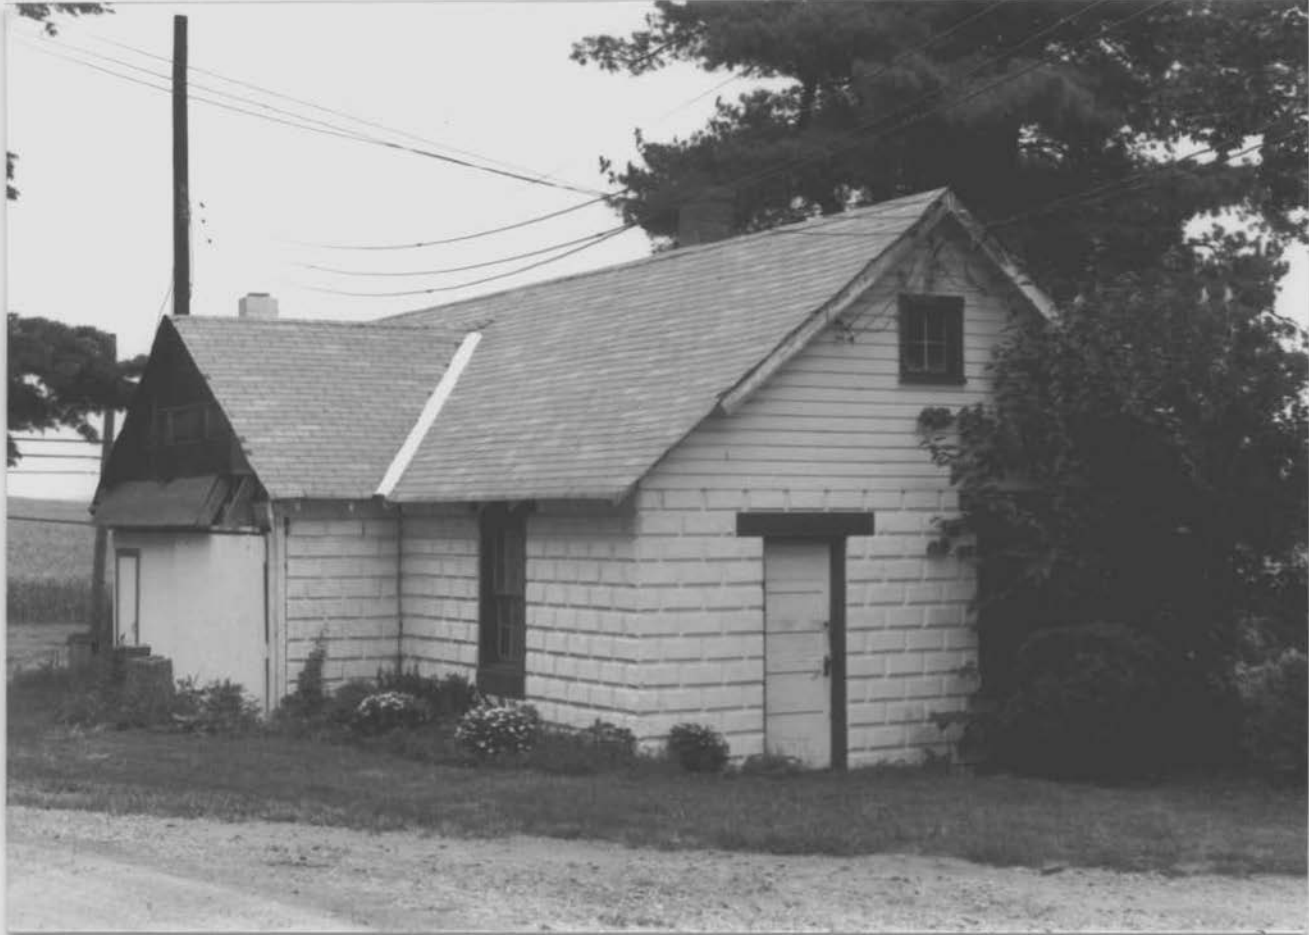
M: 18-23-2

Tavern

Looking northeast

The tavern building is of rusticated concrete block, now painted white. Its gable roof is covered with composition shingles and the gable ends are sheathed with German siding. A small four-light window near the peak of the gable lights the attic. The south elevation has a five-paneled wood door with wood lintel above, and a six-over-six, double-hung window, also with wood lintel. A similar window is in the west elevation, and a small gabled wing projects from this elevation.
