DARNE-PURDUM FARM

14200 DARNESTOWN ROAD, DARNESTOWN

**Maryland Historical Trust
State Historic Sites Inventory Form**

Survey No. M-24-20

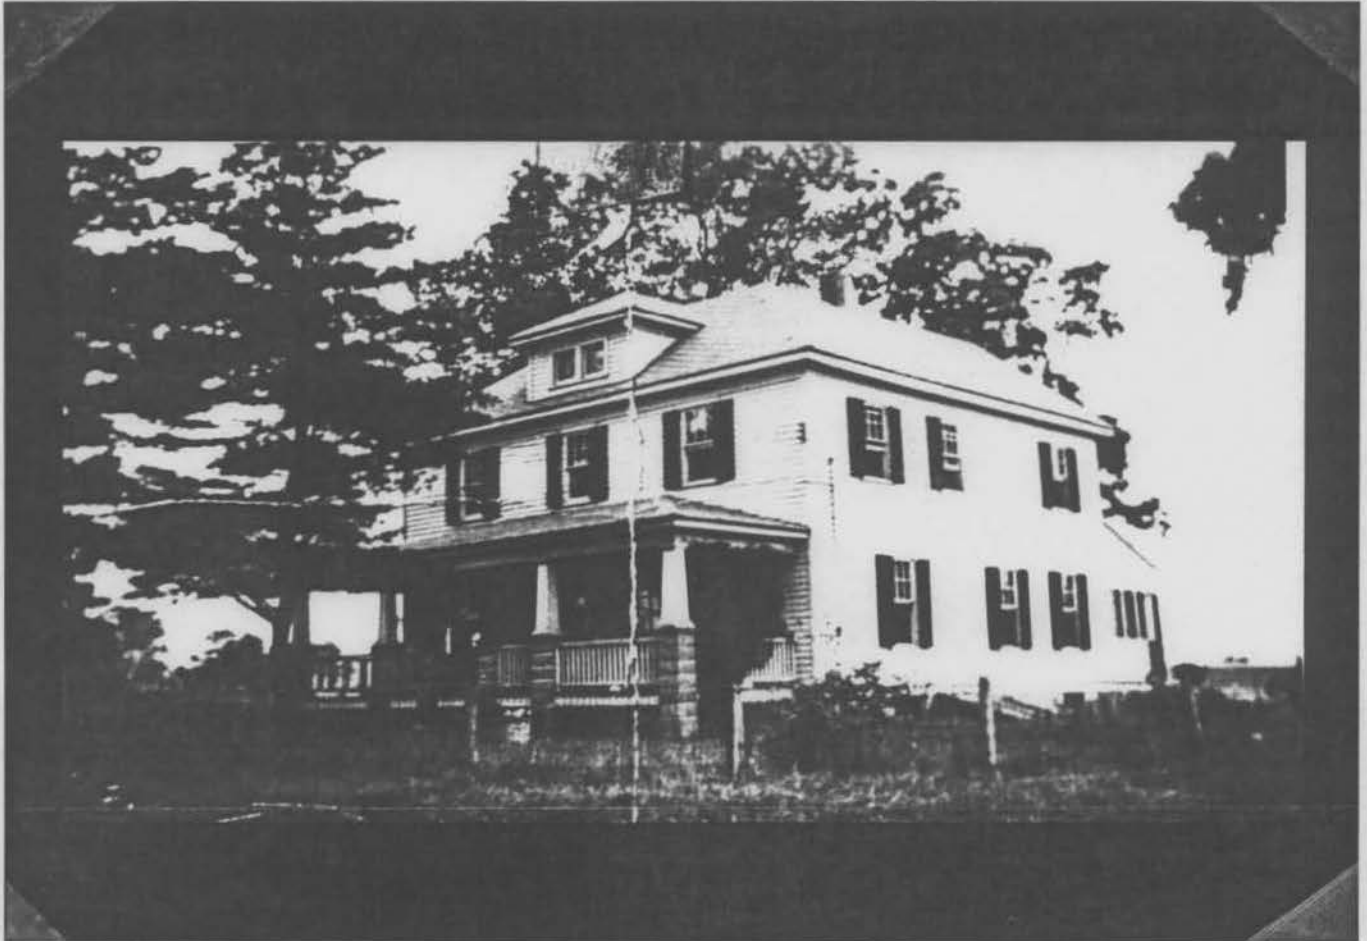
1927 View of Darne-Purdum Farmhouse
Source: Nancy Houston private collection

The Darne-Purdum farmhouse was originally constructed c1853. The original structure is believed to have been a Federal style, two and one half story, three bay structure with an eaves front, gable roof facing west. This section now contains a dining room and kitchen. Around the turn of the century, the house was enlarged with a Four Square style, hip roof section which reoriented the house to face north. An Arts and Crafts style porch with battered columns on rusticated concrete block piers wrapped from the north facade around to the east facade. Shuttered windows contained six over one sash.

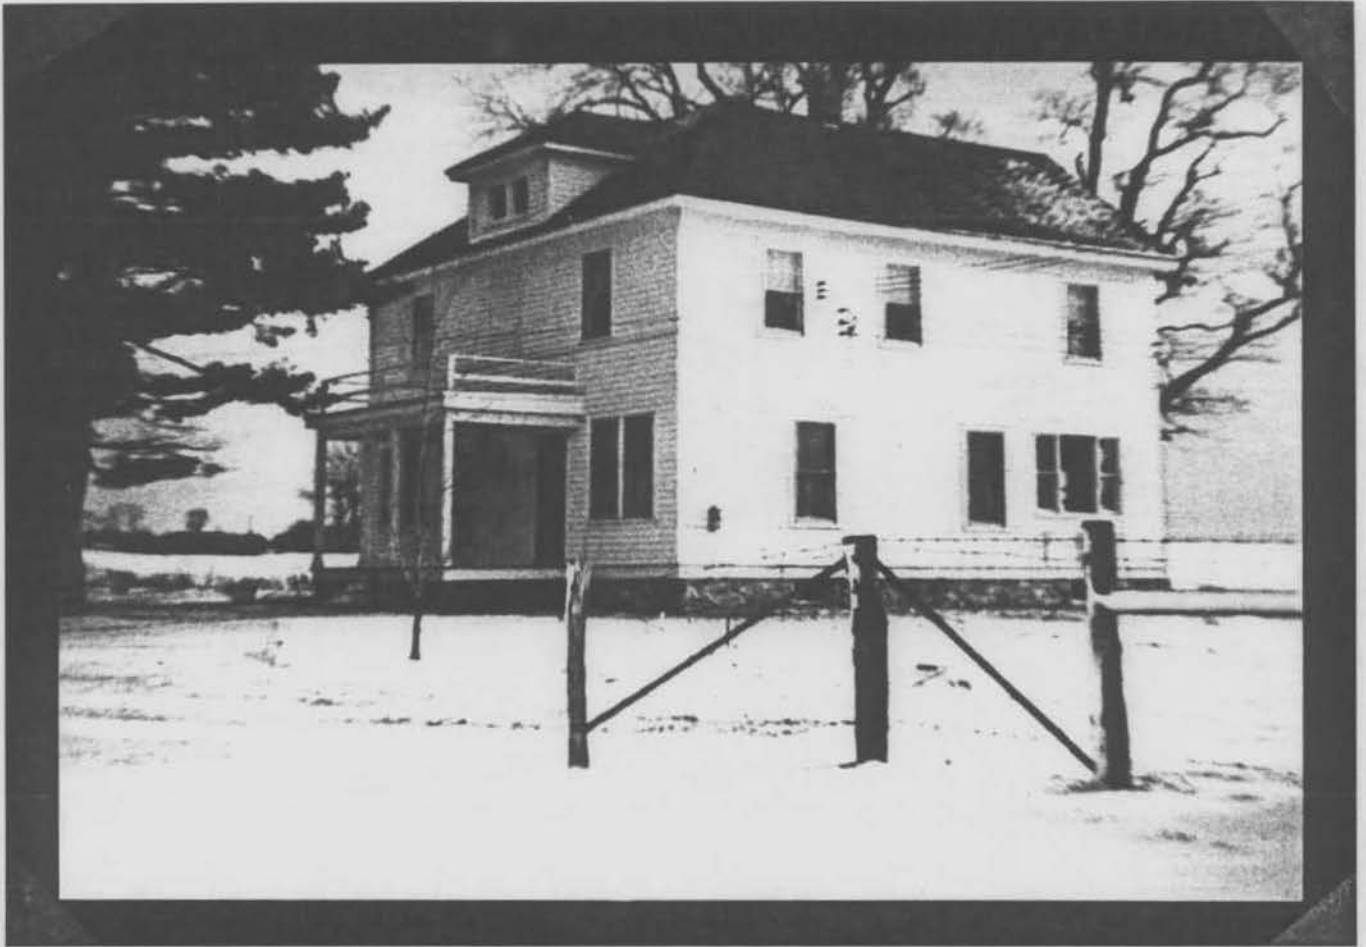
1955 View of Darne-Purdum Farmhouse
Source: Nancy Houston private collection

By 1955, the wrap around porch was replaced with a central flat roofed portico with balustrade, the center window above was replaced with siding, metal storm windows were installed, and a one story, shed roof addition on the north was removed, and two story shed roof addition was built within the rear ell.

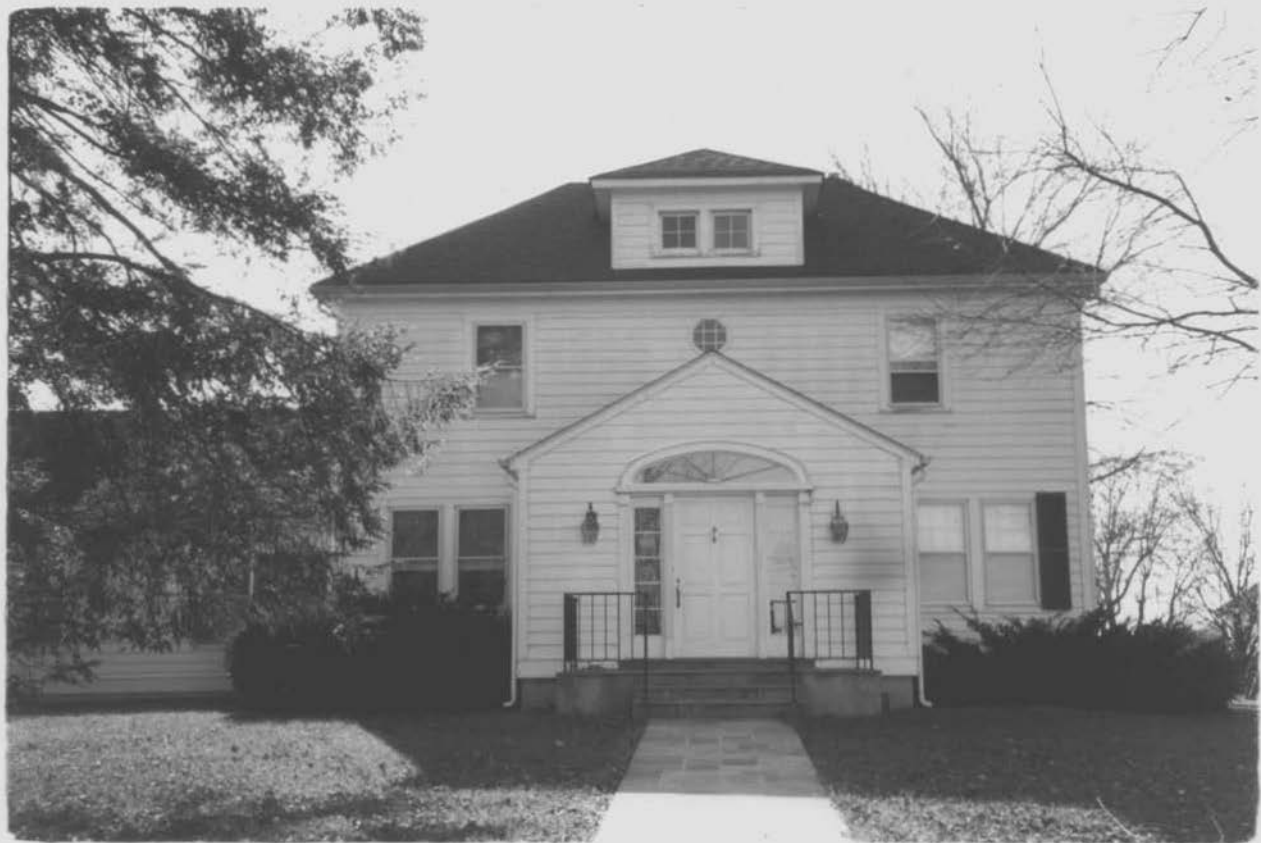
10/14

North

The symmetrical, main (north) facade is three bays wide, dominated by a one story, one bay, front gable projecting entrance vestibule. Entrance is through a Neoclassical doorway with six paneled door, surmounted by a tracery fanlight and flanked by four over-size sidelights. The door is reached by a short flight of steps leading to a stoop which is nearly the width of the vestibule. The stoop and steps are constructed of concrete, covered with stone, and delineated with metal railings. The vestibule is flanked by paired replacement windows with louvered nonoperable shutters.

On the main facade's upper level, centered above the vestibule is a small, octagonal, nine light window flanked by single replacement windows in the outer bays. Centered on the roof above the center bay, is a hip-roof dormer with twin four light casement windows.

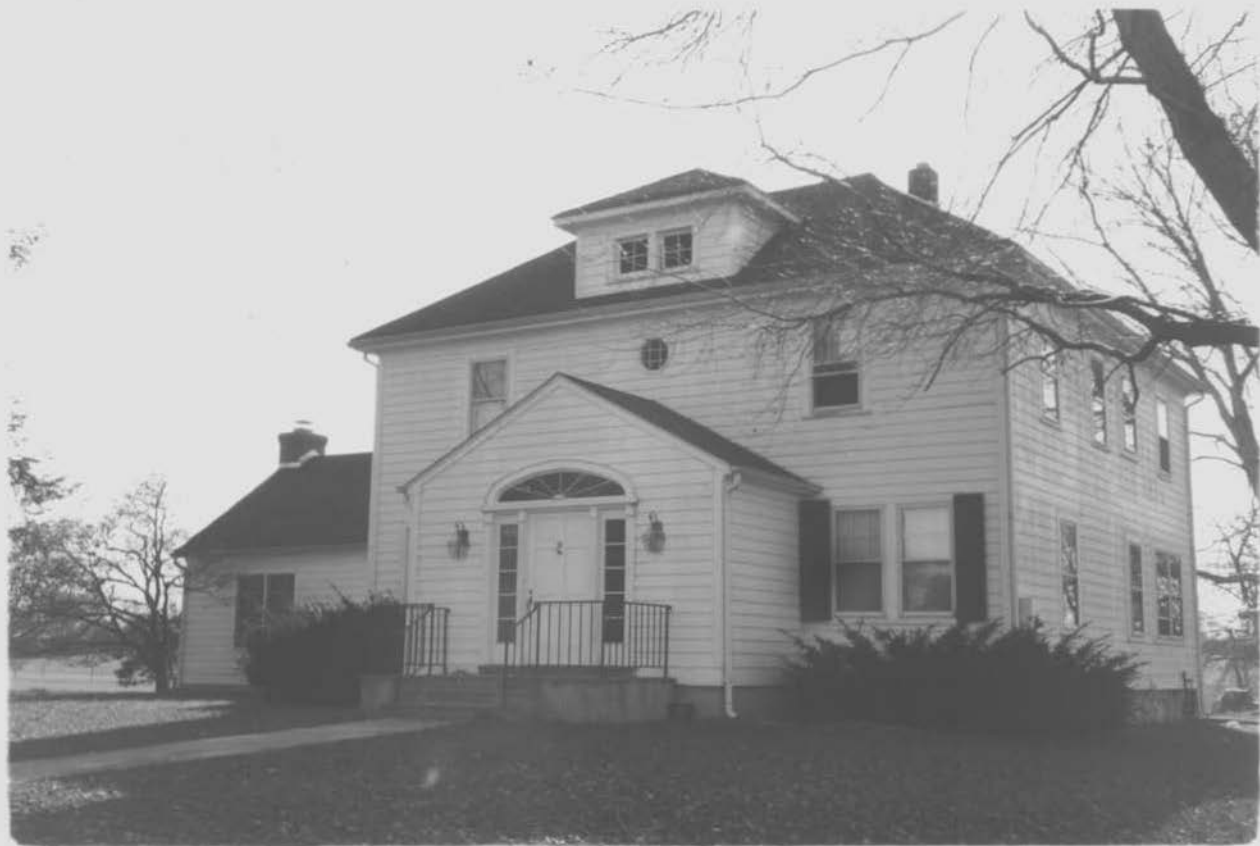
2 of 14

North & West (Right)

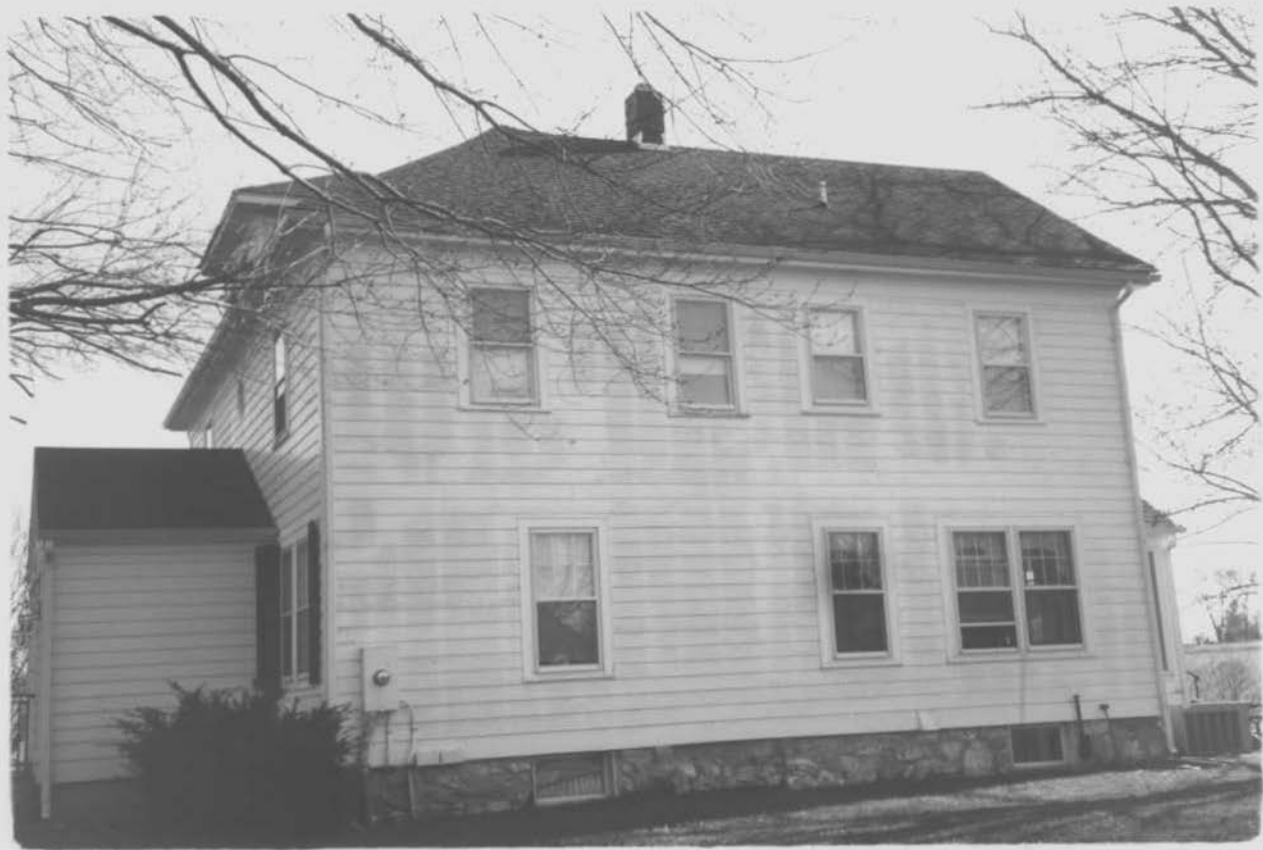
30 of 14

West

The asymmetrical west elevation is four bays wide and was constructed in two sections. The first section was the original c1853 farmhouse front, which is believed to have been three bays wide, being Bays 2, 3, and 4, and terminating in the gable roof at the south end. In the 20th century, the facade was extended by Bay 1 when the present front facade was added. The windows on the entire facade are aligned neither vertically nor horizontally, indicating many changes over the years, beyond the addition mentioned above.

On the first west level, single replacement windows are located in Bays 1 and 3, and paired replacement windows are in Bay 4. The door to the original farmhouse was probably located in Bay 2 which

now contains no opening. On the second level, single replacement windows are located in each bay. The window in Bay 3 is shorter than the others by the height of half a weatherboard. An internal chimney stands on the north-south ridge line above Bay 2.

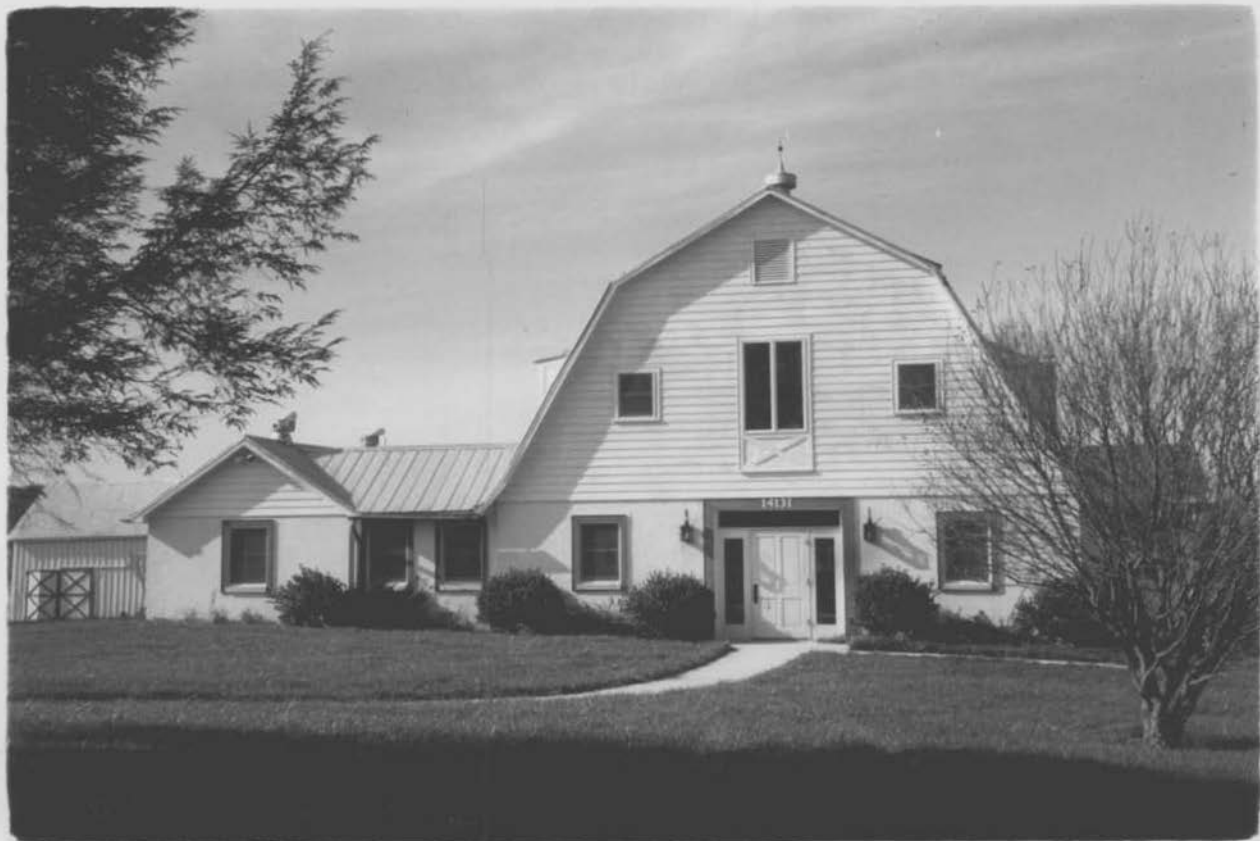
70f14

Darne-Purdum Farm (Outbuilding) (Dairy Barn)

To the west of the house is a complex of farm outbuildings. The largest is the dairy barn, most recently used as a school facility. The gambrel roof barn has concrete block on the first level, weatherboard siding in gambrel ends, and a raised seam, metal roof. The three bay, east facade contains the main entrance through a center, paneled door with single pane transom and sidelights. The entry is flanked by simple one over one sash windows found on the first level of the remaining three facades. Centered above the entrance is a two-pane casement window in a former door opening. The gable end contains a square louvered window. A three bay, hyphen and front gable addition on the south end was originally a milk house. Three ventilators are spaced along the roof ridge line.

In 1987, when the dairy barn was renovated for use as classrooms and administrative space, two front gable dormers were added to the north and south roof planes, and a one story, gable roof addition, one bay by one bay, on the north end of the main facade. The front entrance and replacement windows date from this period.

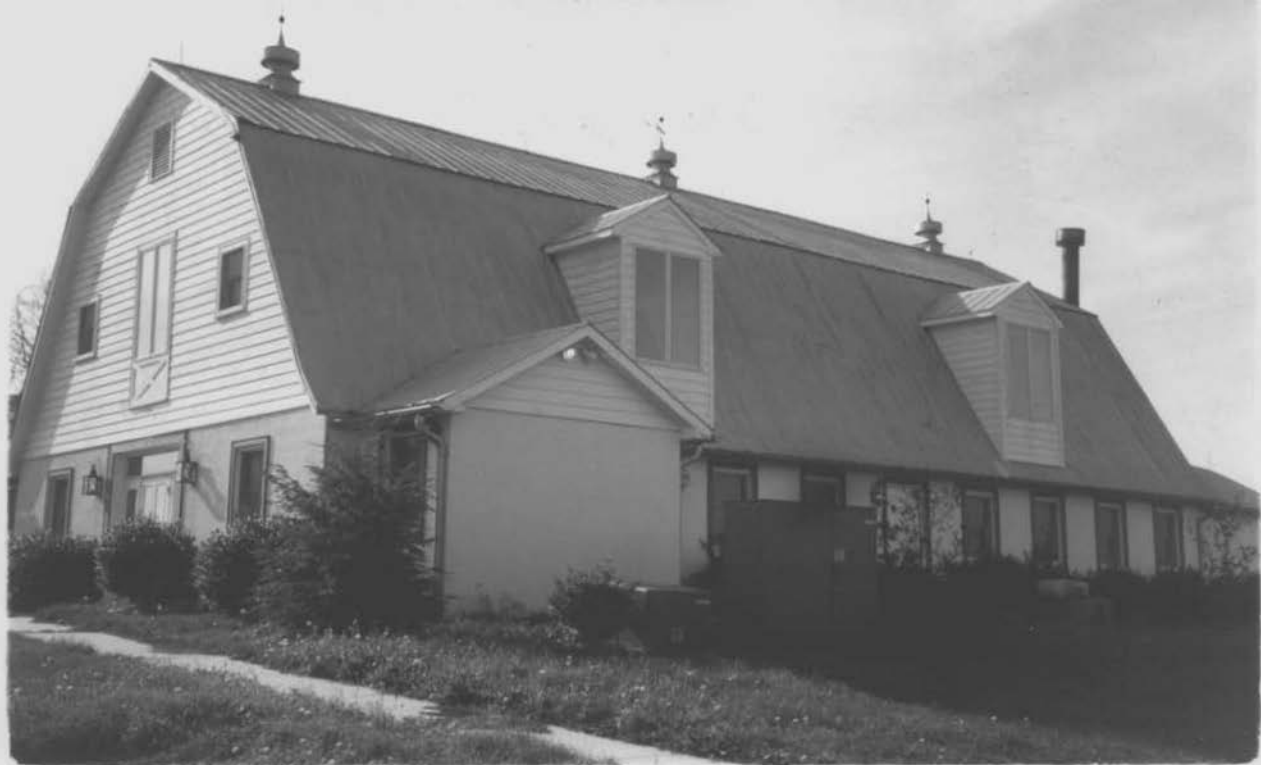
80714

Darne - Purdum Farm (Outbuilding) (Dairy Barn)

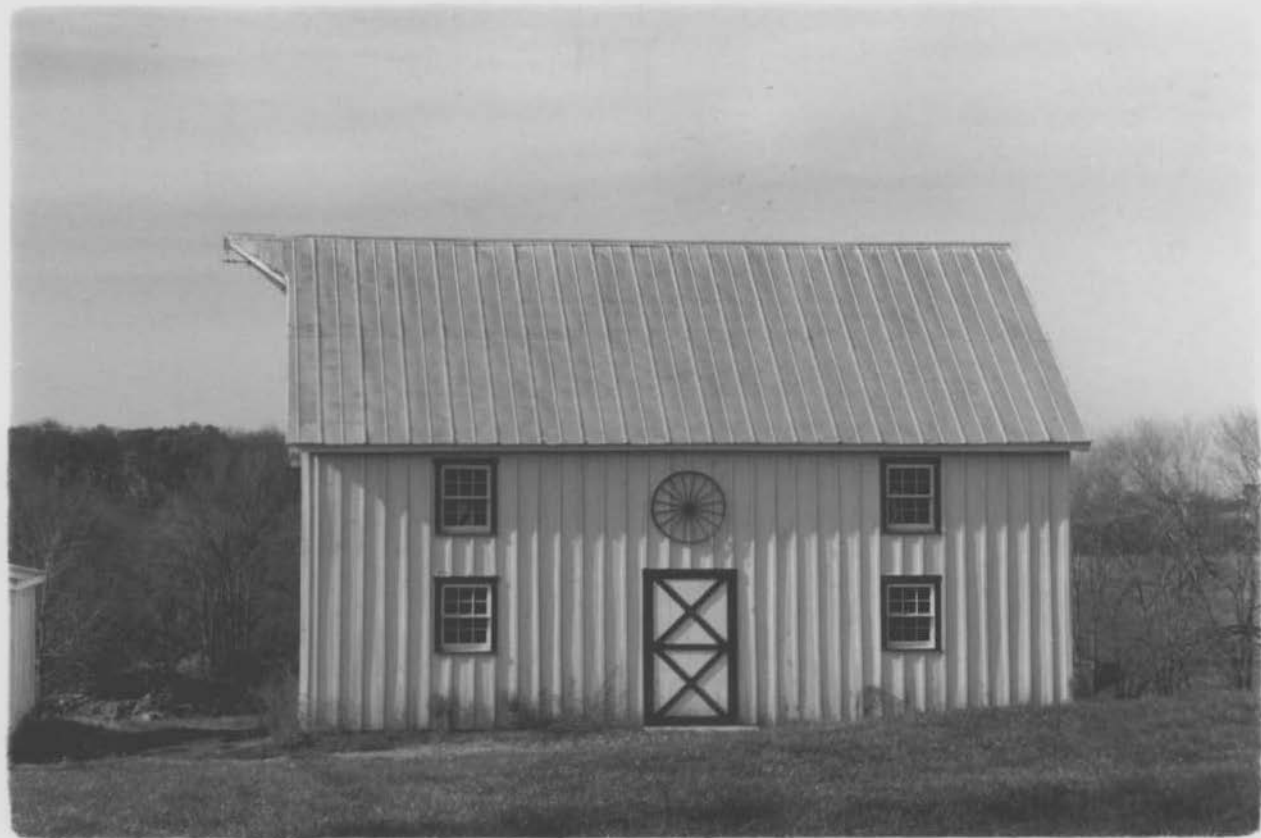
90/14

Darne-Purdum Farm (Outbuilding) (Barn #1)

To the rear of the dairy barn are two other barns, labeled "Barn #1" and "Barn #2" on slides, photographs, and maps, for identification purposes. Both are post and beam construction, with board and batten siding and concrete block foundations. Barn #1 is a three bay, side gable structure with a raised seam, metal roof. The east facade has a center Dutch door at the first level, flanked by six over six sash windows, and six over six sash windows in the outer bays on the second level. The west facade contains only a pair of oversize double hinged doors on the first level. Siding on the east and north elevations was replaced, c1987, when replacement historic windows were installed.

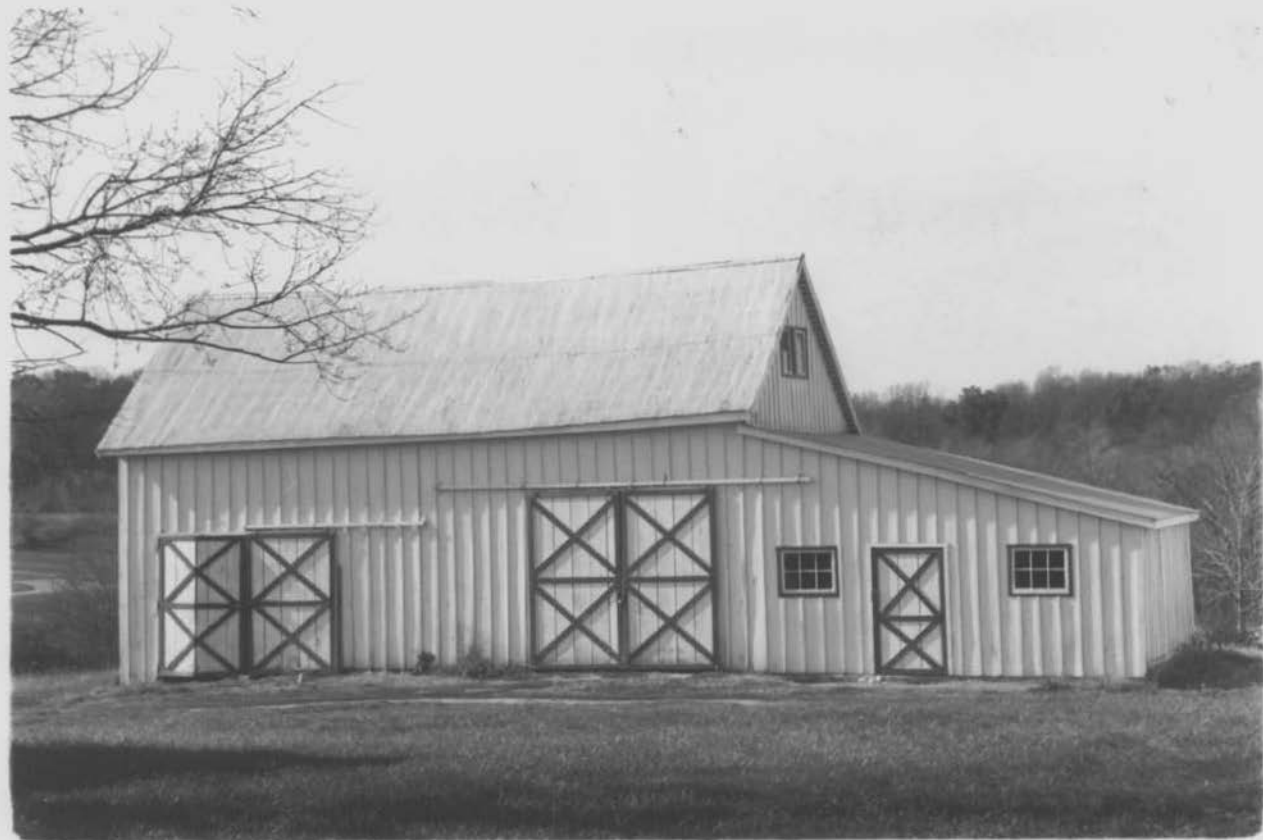
10 of 14

Darne - Purdum Farm (Outbuilding) (Barn #2)

To its south is Barn #2, a two-bay, side-gable English barn with corrugated metal roofs, and six pane casement windows. The east elevation contains two overhead double Dutch doors, one smaller than the other. Attached at the north end is a lower three bay, shed roof addition with a center Dutch door asymmetrically flanked by single windows. On the west facade, the first level of the main block contains another Dutch door flanked by windows and two other single windows are found on the shed section.

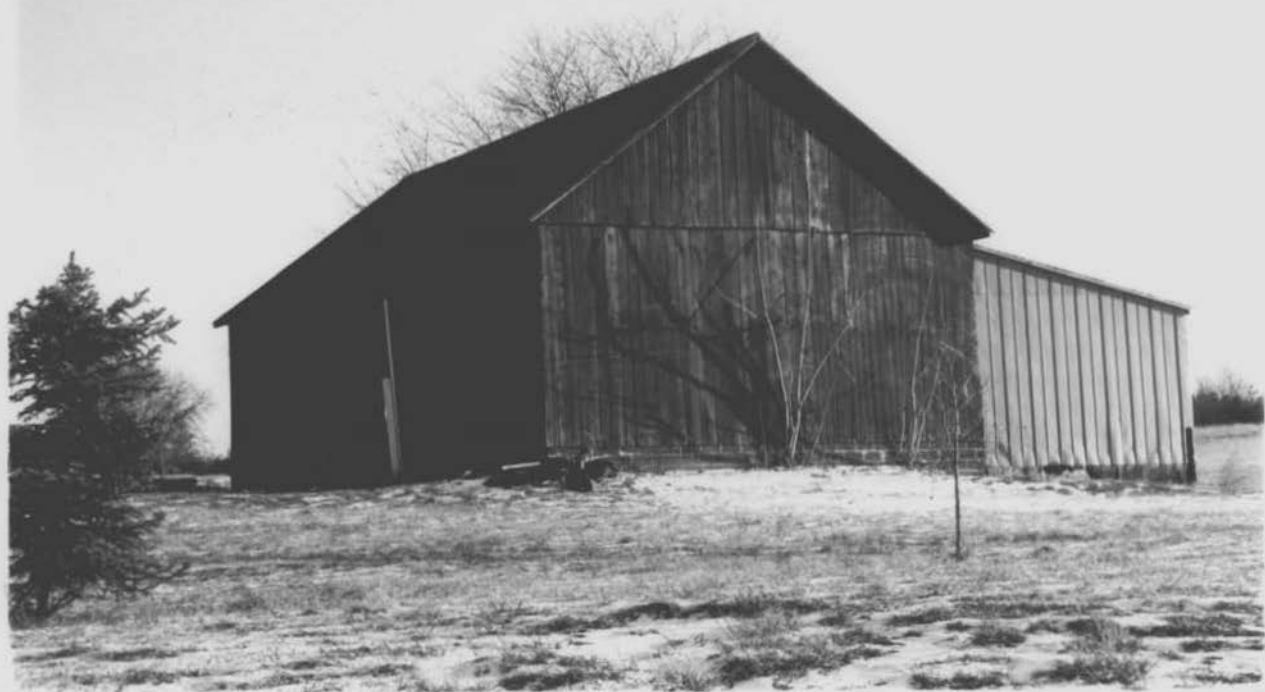
11 of 14

Darne - Purdue Farm (Outbley) (Barn #3)

To the south, across the service road leading to the school dormitory (and away from the main complex of outbuildings) is a large, one bay, side gable barn, Barn #3, with vertical wood siding without battens; raised seam, metal roof; and a concrete block foundation. Entrance is through a large overhead door centered on the north elevation. There is a lower, metal-sided, shed addition at the south elevation.

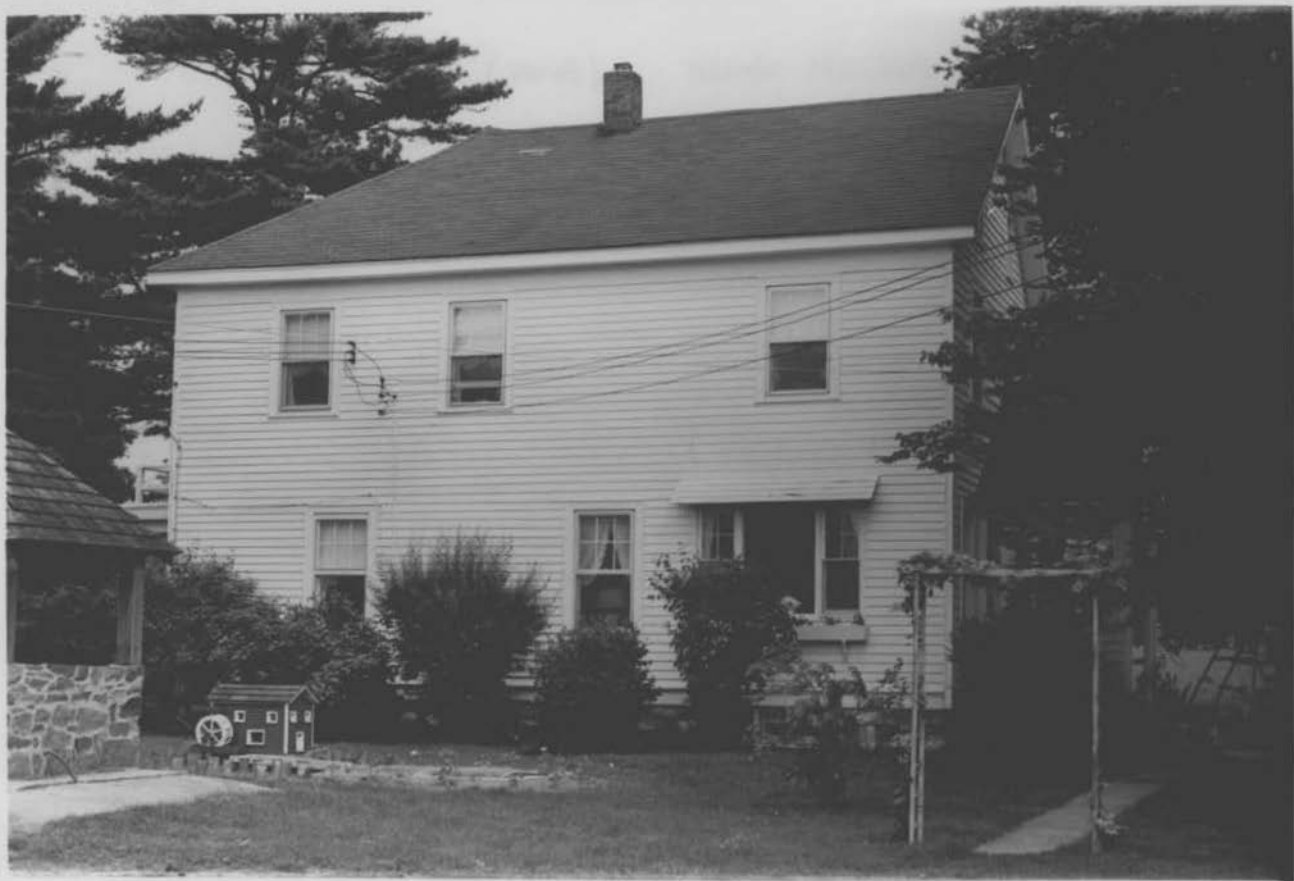
NAME JAMES PURDUM HOUSE (BOYER)
LOCATION Rt 28 + SENECA Rd DARNESTOWN, Md.
FACADE W
PHOTO TAKEN 5/22/74 MDWYER
